Electricom of Miami Thermographic Inspection Report

Sample of an actual report

Plant Station	Communication Center
Thermographer	Leroy Barrett
Date	01/27/1997
Time	01:43:39pm
Component	2e9-1 panel 2 circuit 29 – Supplying critical modems
Equipment Load	8.2 amps
Equipment Location	209-26 2 nd Floor

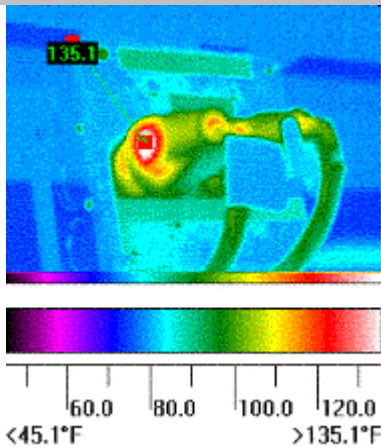
Before repair, image

A - Hot Spot – Before 135.1 after 87.3
 B - Reference temp – 95 degrees F
 C – Temperature rise – 40 degrees
 Classification B

Thermographer's comments: Picture on the left is before the infrared shot. The picture on the right is the shot taken after we changed the electric cords from #18 gauge to #12 gauge

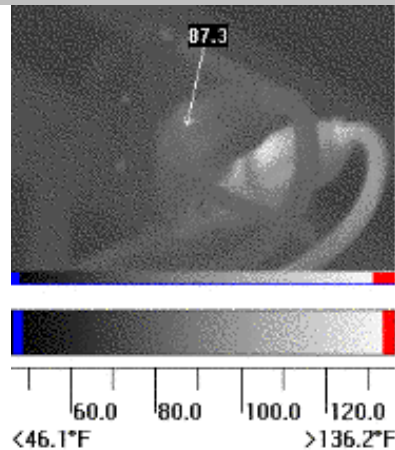
After repair image

Post Repair Inspection Comments: The temperature on the cord went down from 135.1 deg F to 87.3 a difference of 47.8 degrees.
